Manhole Inspection Summary

Manhole # S11II1016MH

Insp Date: **5/24/07 9:08 AM**

Location Address: **3214 WYLIE AVE**

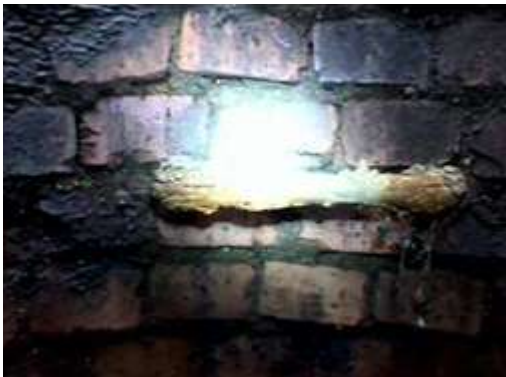
Defect 1

Count: **4** Missing: **0** ☒ **Corroded**

CORRODED RUNG

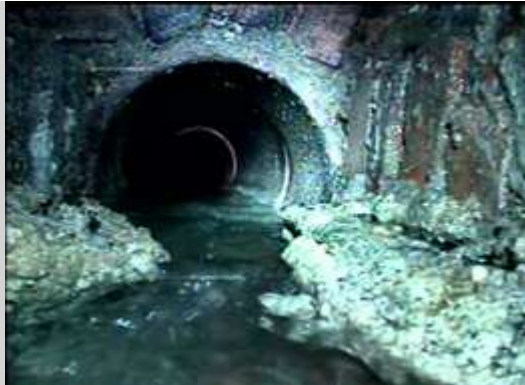
12 O'Clock Outflow

8 in. Circular Gravity Sewer
Pipe Out @ 12 O'Clock

Pipe Height: **9.6** (in.) Rod and Bar (Angled)
Pipe Material: **Clay** ☐ Pipe Lined
Invert Depth: **10.67** (ft.) Flow Characteristics: **Slow**
Deposits: ☒ None ☐ Mud ☐ Sludge ☐ Debris ☐ Grease
Silt Depth: (in.) Deposits Extent:
Infiltration: **None** Pipe Seal Cond: **Sound**

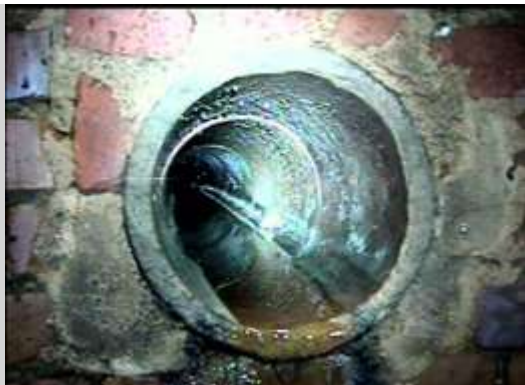
3 O'Clock Inflow

8 in. Circular Gravity Sewer
Pipe In @ 3 O'Clock

Pipe Height: **9.6** (in.) Rod and Bar (Angled)
Pipe Material: **Clay** ☐ Pipe Lined
Invert Depth: **7.66** (ft.) Flow Characteristics: **Slow**
Deposits: ☐ None ☐ Mud ☒ Sludge ☒ Debris ☒ Grease
Silt Depth: **8** (in.) Deposits Extent: **Heavy**
Infiltration: **None** Pipe Seal Cond: **Sound**

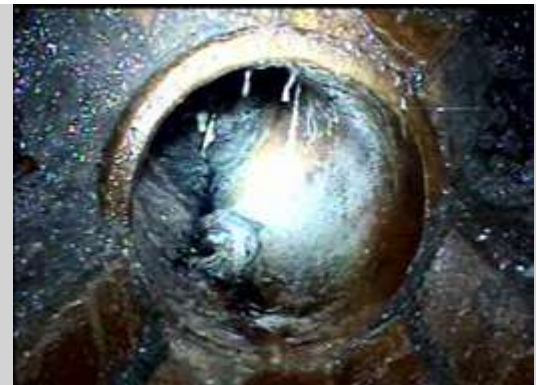
Drop In @ 3 O'Clock

Drop: **Outside** Rod and Bar
Angled: **Yes** Reading: **8.85** (ft.)
Inv Depth: **9.85** (ft.)
Drop Condition: **Clogged**

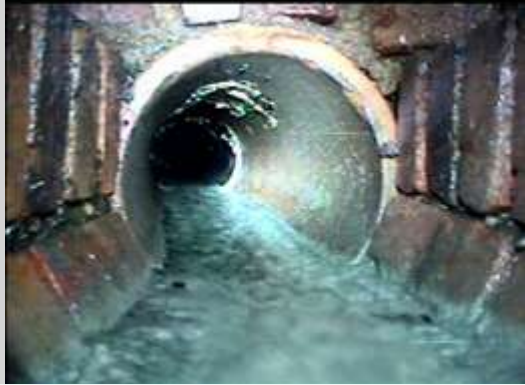
6 O'Clock Inflow

8 in. Circular Gravity Sewer
Pipe In @ 6 O'Clock

Infiltration: **None** Pipe Seal Cond: **Cracked**
